Hendersonville – Hyman Heights & US 25 Walking Audit – April 10, 2006

The Walk Wise, Drive Smart project is a community-wide effort to promote safe, healthy walking in Hendersonville, NC neighborhoods. Helping address areas such as Hyman Heights and US 25 are important to developing community-wide solutions. Observations and recommendations from this audit are intended to inspire broader attention to walking conditions in Hendersonville.

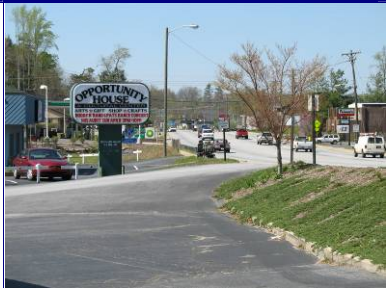
Item	Location	Description	Category	Photo
1 📄	Opportunity House	<i>Access to Businesses and Community Center.</i> Pedestrian access to and from the street at Opportunity House is typical for businesses along the stretch. The parking lot separates the sidewalk from the building entrance and includes a steep grade that is a challenge to climb and also blocks the visibility of entering drivers entering from US 25. New pedestrian-friendly design standards often involve putting the building face close to the street to facilitate access and improve the feel of the neighborhood.	Access

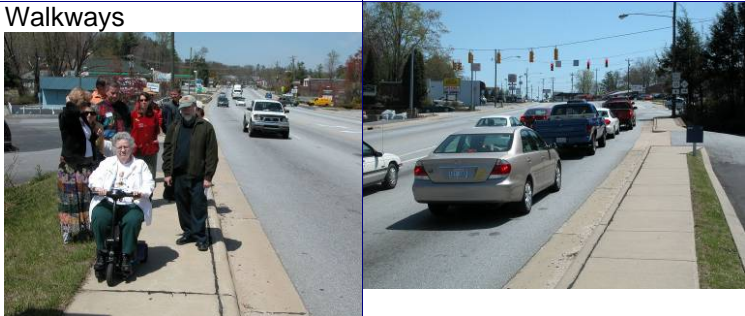
2 📄	Rte. 25	<i>Buffer & Walkway Width</i> There is no buffer for the walkway along US 25. This creates hazards for pedestrians and an uncomfortable environment for drivers as well. Notice how members walk away from the street where possible. Passing vehicles can be seen shifting over toward the lane divider, as well.	Walkways

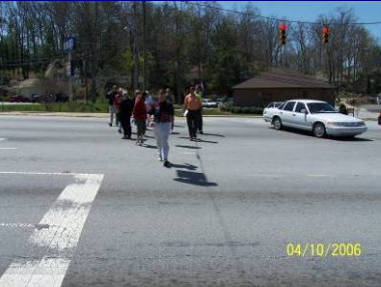
Item	Location	Description	Category	Photo
3 📞	NC 191 & US 25 intersection	<p><i>Crosswalks missing.</i> This intersection provides no marked or signalized crossings across US 25. This is a legal crosswalk, but does not afford any facilities to make crossing here a safe option. Marking crosswalks and adding pedestrian signal heads (especially countdown signals) is recommended. Many other state highways would recognize every signalized intersection as a legitimate place for pedestrians to cross the highway.</p>	Crosswalks

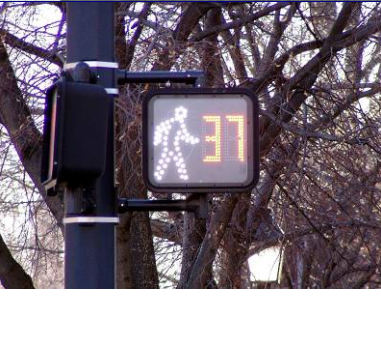
4 📞	NC 191 & US 25 intersection	<p><i>Signal timing is inadequate for crossing on foot.</i> The fact that this intersection establishes legal (though unmarked) crosswalks does not mean that it is presently safe to cross here. We crossed US 25 departing from the pork chop island on the north side in a platoon, and waving at the waiting drivers who received a green before we could finish crossing. Large crosswalk spans are enhanced by the installation of ped-heads with countdown signals. New MUTCD recommendations under review will establish timing standards for flashing “don’t walk” at a 3.5 ft/sec pace and the total time (with “walk” phase) at 3.0 ft/sec.</p>	Signal timing Example photo --> (Courtesy Dan Burden)

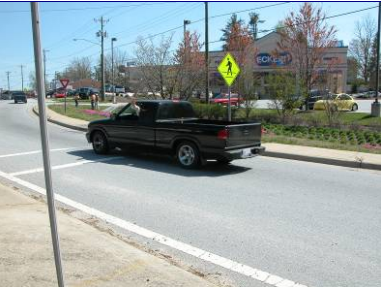
5 📞	NC 191 & US 25 intersection	<p><i>Crosswalk across 191 S/B entrance to S/B 25 appears unsafe due to driver behavior.</i> Drivers here were observed to completely ignore the requirement to yield. A curb extension, high visibility crosswalks, targeted enforcement, stop lines, advance educational signage, and other such treatments could improve compliance.</p>	Driver compliance with yield to peds

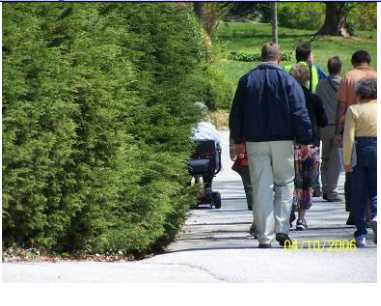
6 📞 ★	Oakland & Crescent	<p><i>Traffic speed & volumes on residential streets.</i> Residents of Hyman Heights note that speed, traffic volume, and one-way non-compliance problems are significant and attributable to cut-through traffic between US 25 and points to the east. There is poor connectivity and “permeability” due to the historic street grid and topography of the area. The current one-way streets was an initial attempt to mitigate this problem and further action may be warranted. This is an opportunity for traffic calming & citizen action.</p>	Traffic Calming

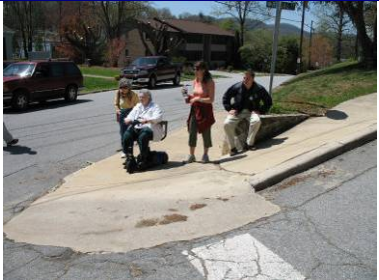
Item	Location	Description	Category	Photo
7

Oakland & Regal	<p><i>Extreme sidewalk slope at corner.</i> This slope is beyond the limits of a wheelchair or scooter's capabilities and would preclude turning onto Regal. The older walkways are not designed to be compliant with Americans with Disabilities Act standards. It could be a good citizen-initiative to document or map sections of sidewalk throughout the community for future prioritization. This location may not be a top priority, but is an example of a barrier for wheelchair users.</p>	Walkways

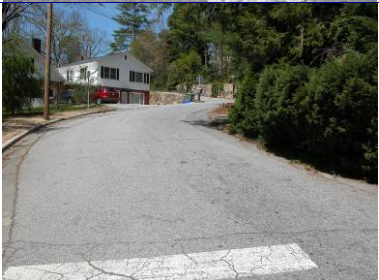
8

Regal	<p><i>Blind curve.</i> This street was reported to be a location where vehicle speeds are excessive. This could be a good location for enforcement efforts.</p>	Visibility

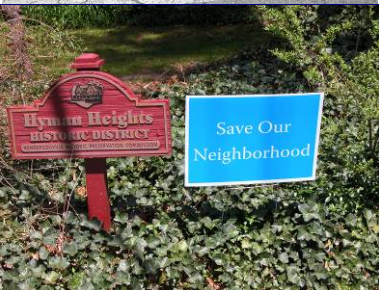
9

Hyman Heights	<p><i>Contrast between residential & commercial areas.</i> The complete separation of residential and commercial land uses between the US 25 business corridor and the residential neighborhood result in drivers entering the area with an inappropriate mental framework. Mixed-use development on US 25 could be a desirable improvement. Communities across the country are establishing mixed-use standards for new commercial development.</p>	Land Use

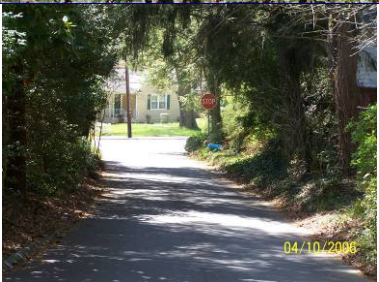
10

Waynesville Street	<p><i>Wrong way driving.</i> There was some mention of an occasional wrong way driver. Signage or traffic calming may improve this situation. Simple features such as chokers or just paint and signs can improve compliance. A traffic calming plan for Hyman Heights, however, is likely to offer better results than making only isolated changes.</p>	Driver compliance

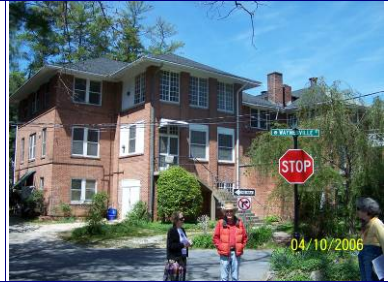
12 ☞	Hyman Heights	<i>Walking loop</i> An informal walking loop exists as a sort of promenade through the neighborhood. The route runs (counterclockwise) along Oakland extension to Oakland St to Killarney to Highland to Waynesville.	Walking routes

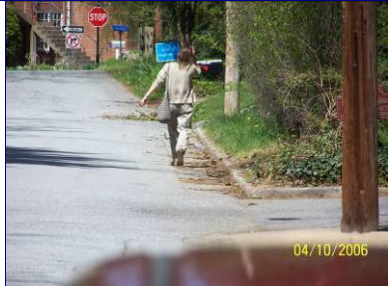
13 📞	Killarney Street	<i>Lack of Compliance with One-way Street</i> Residents noted that drivers turn the wrong way on Killarney with great frequency. Here, we observed that sign placement and marking could be improved. <ul style="list-style-type: none"> • "Do not enter" sign too far back and small (stop sign also in location that makes it hard to see). • One-way sign could be closer to corner on post. • Short stop line placement for correct way traffic makes the street look like it is two-way to approaching drivers: instead, extend stop line across full street width. • Add a one-way directional arrow on pavement. 	Signage & Pavement Markings

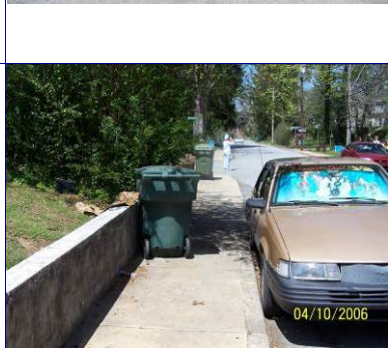
14 ★	All sidewalks in area	<i>Trash Cans on Sidewalk</i> This is permissible according to Hendersonville ordinances, but it reduces sidewalk width and creates an obstacle for users. An education campaign could be launched by neighborhood councils and the Public Works department to communicate that trash cans may be placed off the sidewalk in front yard or in parking areas and still be successfully emptied.	Public Education (Public Works)

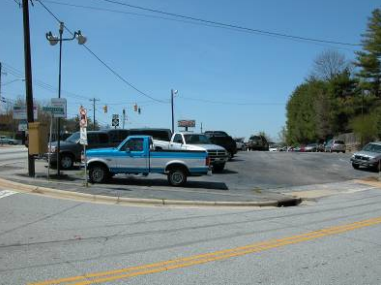
Item	Location	Description	Category	Photo
15

Lot at Schepper & Oakland & 25	<p><i>Proposed Walgreens development</i></p> <p>Concerns were raised about a proposed Walgreens drug store that would take over the car lot at the corner of US 25 and redevelop residential property all the way to Schepper. Several options exist for neighborhoods opposed to this development:</p> <ol style="list-style-type: none"> 1. Counter the NIMBY image (Not in my back yard) by gathering information about community clashes with Walgreens around the United States. A simple Google search yields numerous stories of similar clashes. This contest should not be simply about opposition at this particular location. It can highlight trends in how a corporation may be disregarding the quality of a local conditions and should set a precedent for other Hendersonville neighborhoods and beyond. 2. Establish a list of specific demands from the neighborhood. New development can be a positive force that creates good things for the community, but to accomplish that, it is often a negotiation. Other communities have succeeded in getting mitigation money on the order of \$50,000 to improve walking conditions and streetscapes. 3. Consider this as a test case that can help establish new or improved standards for the City of Hendersonville. New development can be a positive force of change, especially with your leadership. 	Land Use

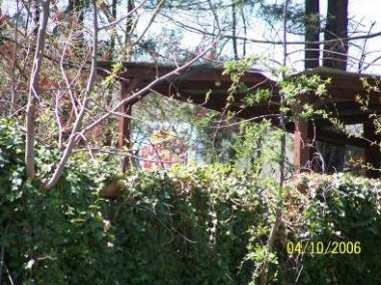
16

End of Schepper Street	<p><i>Burger King Trail</i></p> <p>It was noted that this path that connects the dead end of Schepper with US 25 is a location for littering and other activity. The presence of this pedestrian connectivity is a positive asset in the community. The Hyman Heights neighborhood could reclaim this path through a clean-up and improvement work party. Likely such an effort could attract support from businesses such as Burger King itself.</p>	Litter

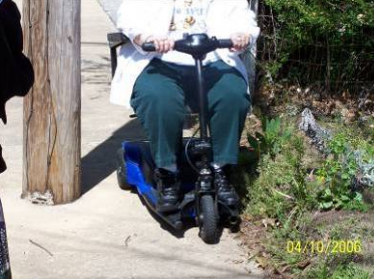
Item	Location	Description	Category	Photo
17

Oakland Street Sidewalk	<p><i>Telephone pole in sidewalk</i> This obstruction narrows the sidewalk. Future utility work should be monitored to ensure that it does not reproduce these obstacles.</p> <ul style="list-style-type: none"> • 36" clearance on the walkway is required by ADA 	Walkways

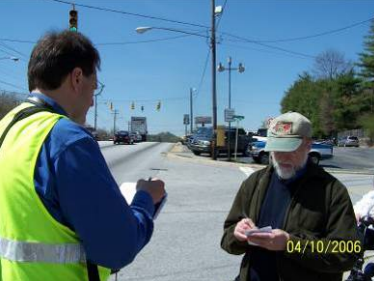
18

Oakland & US 25	<p><i>Curb radius at intersection</i> The large curb radius at this intersection creates a long crossing for the crosswalk across Oakland. Several problems arise from this:</p> <ul style="list-style-type: none"> • By allowing drivers to turn less than 90 degrees, they do not slow when turning off US 25. • The distance to cross Oakland is excessive. • Speeds turning onto Oakland should be slowing to 20 mph, not zooming through. 	Street geometry

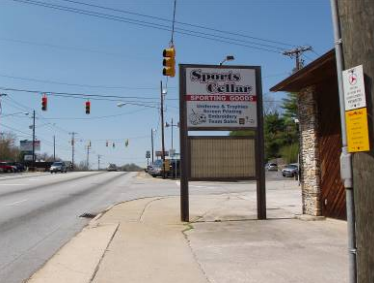
19

Oakland & US 25	<p><i>Visibility of pedestrians at corner</i> The signage here blocks the view and mobility of pedestrians (and vehicles) approaching US 25. Changing the standards to make it sure that such a view blocker does not occur in the future could be a task for the city's planning commission. NCDOT may also already have restrictions on the books that provide a means for eliminating unsafe signage.</p>	Commercial Sign Standards

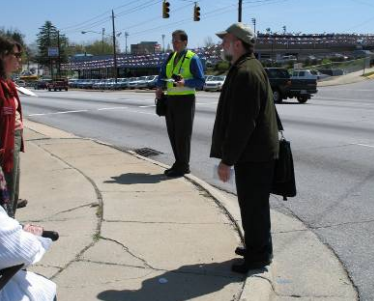
20

Oakland & US 25	<p><i>Immaculata Catholic School & Hendersonville Middle School Crossing</i> We learned after the audit that Immaculata parents had been requesting that this intersection be upgraded to include crosswalks for middle school students. Apparently, these parents' pleas were ignored, making it an insult when the mid-block crosswalk was painted for the car dealership. This request deserves a response.</p>	Safe Routes to School

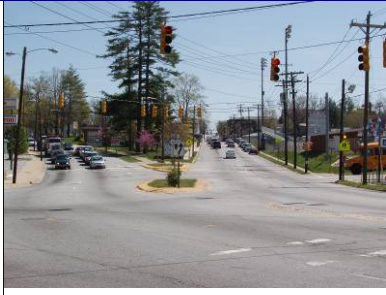
Item	Location	Description	Category	Photo
21 📞	US 25	<p><i>“Closed Loop” Signal System planned for US 25</i></p> <p>The NCDOT Sylva transportation control center is presently establishing the specifications for a new coordinated system of 48 traffic signals along US 25 and US 64 through Hendersonville. This is a tremendous opportunity to include pedestrian detection, count-down signal heads, and pedestrian-friendly signal timing for the area. The city manager is advised to send a letter to the NCDOT division director demanding that the community’s pedestrian needs be incorporated into this system .</p>	Traffic Signals

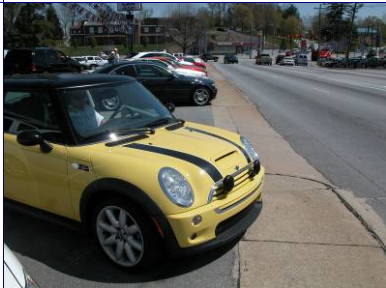
22 🚶	US 25 East Side	<p><i>Sidewalks in terrible condition.</i></p> <p>These sidewalks are narrow, oscillating, adjacent to the roadway with no buffer, and are not compliant with ADA standards. Normally, new development is the means for upgrading sidewalks, but with a car dealer at this location that day may be many years away. Hendersonville & NCDOT should collaborate to determine a means for upgrading these sidewalks through TIP or other funding.</p>	Walkways

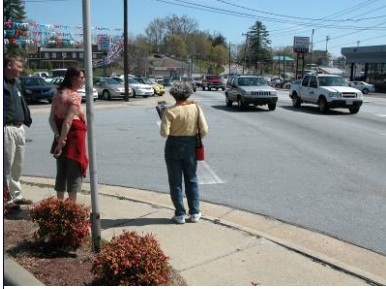
23 📞	US 25 @ Patton	<p><i>Excessive crossing distance.</i></p> <p>This wide side-street crossing is a significant barrier to walkability. Wide crossings like this can be eliminated through the use of curb extensions, which will simultaneously reduce speeding on residential streets. Sometimes there is a concern about dramatic bulbouts that slow traffic exiting a major corridor (due to potential for rear-end crashes), but (a) this is a lower-speed portion of US 25, and (b) an asymmetrical curb bulbout on the Northeast corner could be very effective.</p>	Crosswalk

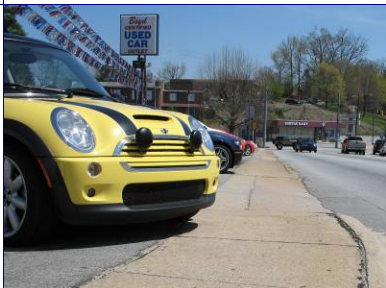
24 🌟	Boyd Car Dealership	<p><i>Cars parked onto and blocking sidewalk.</i></p> <p>These vehicles are illegally parked. The dealer will have several incentives for doing so: (a) greater visibility for vehicles for sale, (b) more space in the lot, and (c) the lack of wheel stops makes it hard to determine where to stop. The city and community should extend a kind but firm hand to the dealership prior to ticketing all of the cars on the sidewalk. Make them a partner in improving the area.</p>	Parking

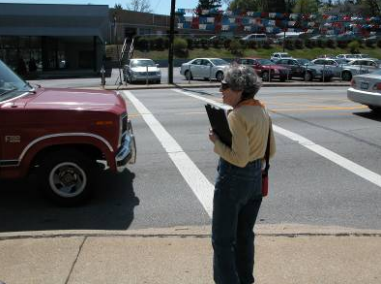
Item	Location	Description	Category	Photo
25 📞	US 25 between Patton & 5-points	<p><i>Mid-block crosswalk markings a safety hazard.</i></p> <p>The design of this mid-block crosswalk makes it likely that at some point in the future there will be a pedestrian injury due to the inability of a driver and a pedestrian to see one another. If Carla departs across the street here, the truck would block the line-of-sight of traffic in lane 2. Multiple-threat crashes can be reduced by adding a stop line, high-visibility crosswalk markings, and a raised center median.</p>	Crosswalk

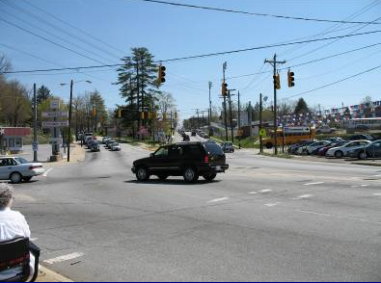
26 📞	5 points intersection	<p><i>Curb ramps, timing.</i></p> <p>When this intersection was improved several years ago, pedestrian signal heads were added. However, the curb ramps were not upgraded, making it dangerous and inconvenient for a wheelchair user to cross. Our scooter user tipped onto 2 wheels when using a car lot driveway to mount the sidewalk about 20 feet south of the marked crosswalk. High visibility crosswalk markings and 8-foot advance stop bars are also needed.</p>	Crosswalk

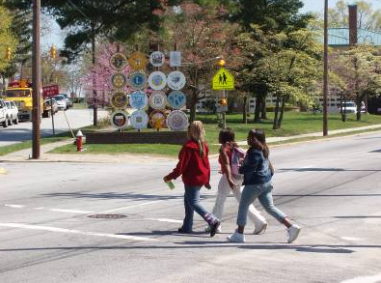
27 ✨	5 points intersection	<p><i>Risky behavior of high school students crossing.</i></p> <p>While observing this intersection, at least four sets of pedestrians crossed in the center of the intersection, away from the crosswalks. When confronted, these girls stated that they were heading to the Boys & Girls Club behind the northeast corner. Several factors appear to be influencing this behavior: (a) lack of high visibility markings, (b) presence of refuge median on south side of intersection, but no similar refuge for the north side of intersection, (c) poor crosswalk design on and from east side of 5-points establishes poor habits when crossing in reverse direction. Design improvements and a collaboration with Boys & Girls Club around education of HS students is suggested.</p>	Pedestrian Education

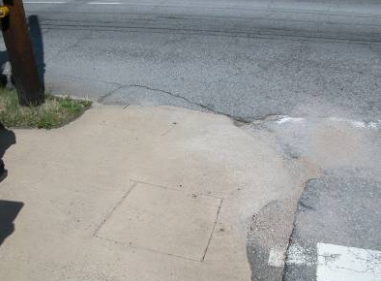
28 📞	5 points intersection	<p><i>Right turning vehicles onto Ninth St.</i></p> <p>This curb has disappeared! Behind this curb, there are major view obstructions in the form of multiple utility poles. Vehicles turning right from US 25 to Ninth could be endangering pedestrians. A leading pedestrian interval, utility pole removal, and improved curbing are suggested.</p>	Curbing

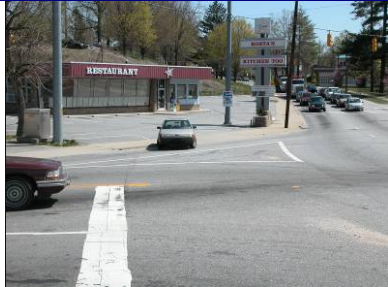
Item	Location	Description	Category	Photo
29 📞	5 points intersection	<p>Roundabout?</p> <p>This intersection is just too darn complicated. It appears to be a good candidate for a roundabout. With the investments slated for the corridor's signalization, and the large land area already available here, a modern roundabout design should be investigated by NCDOT and the City. Modern roundabouts can be excellent for pedestrians because traffic flows slowly enough that drivers automatically yield to pedestrians at crosswalks.</p>	Intersection Design

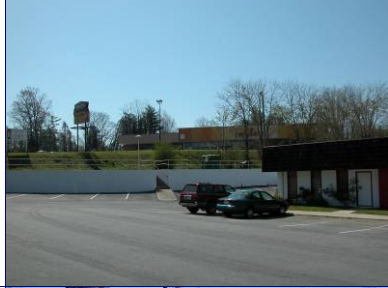
31 🚶	Fleming & US 25	<p><i>Old Ingles Store.</i></p> <p>Empty parking lots and closed businesses are terrible signs for a community and create dead-spaces without eyes on the street. The Tipping Point, by Malcolm Gladwell describes how a community can make statements in the way it responds to or ignores such issues.</p>	Land use, Art, Private Development

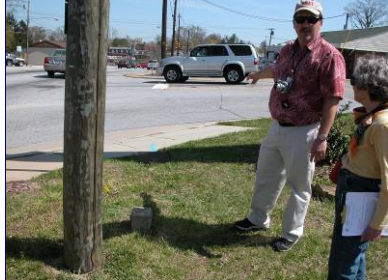
32 🚶	US 25	<p><i>Right of way marker.</i></p> <p>The street right-of-way (or ROW) almost always extends beyond the paved area. One gage of this is where the utility poles are located, but on US 25, we saw a rare marker. The ROW for US 25 appears to have been expanded to the north at some point in the past. It's usually less onerous to acquire property on only one side of the street than on both sides.</p>	Concept of right-of-way

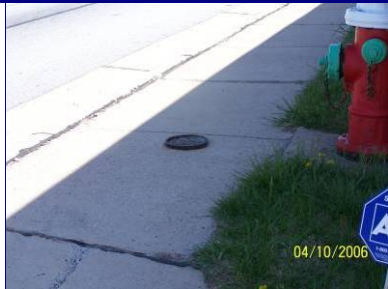
Item	Location	Description	Category	Photo
33

US 25	<p><i>Trip hazards.</i> The sidewalks on our walk did not have many significant cracks, but this water meter cover is protruding in a way that made it a hazard to walkers and wheelchair users. When one is walking so close to the highway, tripping would be not only injurious, but also potentially life threatening.</p>	Walkway

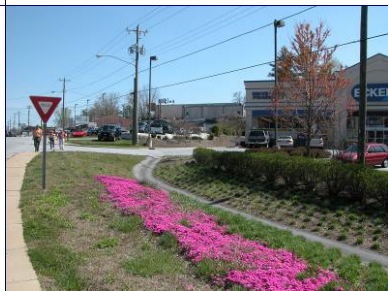
35

US 25	<p><i>Driveway Access to Eckerds.</i> Concerns were raised about drivers entering Eckerds by turning left from northbound US 25. This location appears particularly hazardous. NCDOT reported that they would examine crash history to determine whether a left turn restriction (e.g., in the form of a raised center median) is warranted here.</p>	Access Control

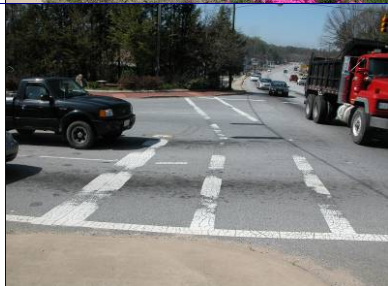
36

US 25	<p><i>Faded Pavement Markings.</i> High visibility crosswalk markings can be striped so as to minimize wear due to tire abrasion. April can be a time of year when markings are in their worst condition, after a season of snow, but before maintenance has moved into full swing. One NCDOT engineer indicated they are experimenting with new more durable marking treatments that may reduce the annual fading observed here.</p>	Pavement Markings (NCDOT, City Public Works)

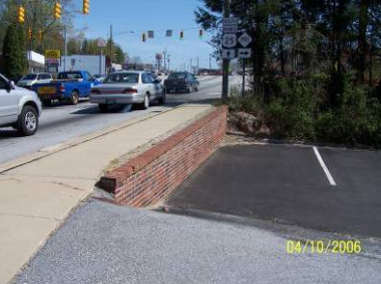
Item	Location	Description	Category	Photo
37

Suntrust bank	<p><i>Handrail requirement.</i></p> <p>Due to the drop-off from the sidewalk to the parking lot, a hand-rail should have been installed here at the top of the brick wall. Suntrust Bank would be advised to make this improvement.</p>	Walkways

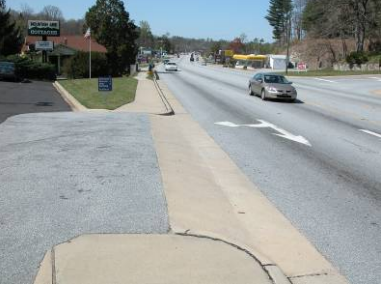
38

Suntrust Bank	<p><i>Cut-through traffic to Druid Hills.</i></p> <p>Participants noted that drivers routinely turn right off US 25 through this parking lot to reach the West side neighborhoods including Druid Hills. Representatives of Druid Hills noted that the traffic calming measures within their neighborhood have been extremely effective. One person noted that the reduction in cut-through traffic now means that they are more comfortable with their children again playing out in front of their houses.</p>	Access Control

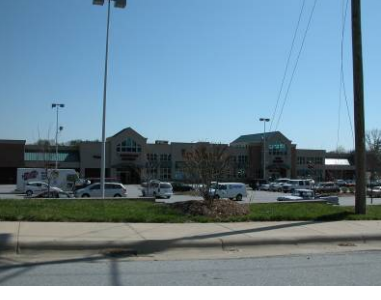
39

The New Ingles on US 25	<p><i>Lack of nearby crosswalk.</i></p> <p>Though we did not walk here during the audit, one participant noted that there is no crosswalk near the new Ingle's on US 25. Because having a grocery store nearby has been found to be the single greatest generator of pedestrian activity (University of Washington Urban Form Lab study), we recommend that NCDOT, Hendersonville, and the property owner collaborate to identify a way to add a crosswalk at this location. Additionally, all new grocery stores should include accommodations for pedestrians.</p>	Crosswalks & Land Use
